## Fort Campbell Childers House

Historic Maintenance and Repair Manual

September 2006

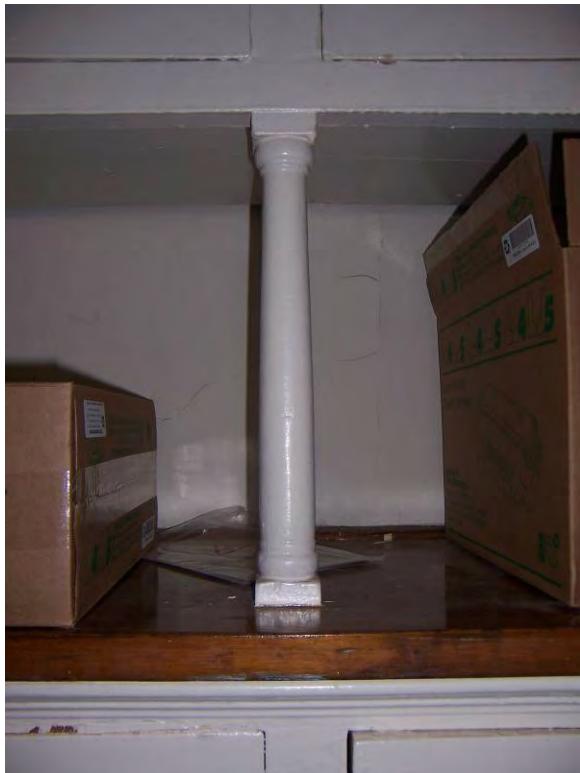
Figure 154. Detail of column on cabinets in hyphen.

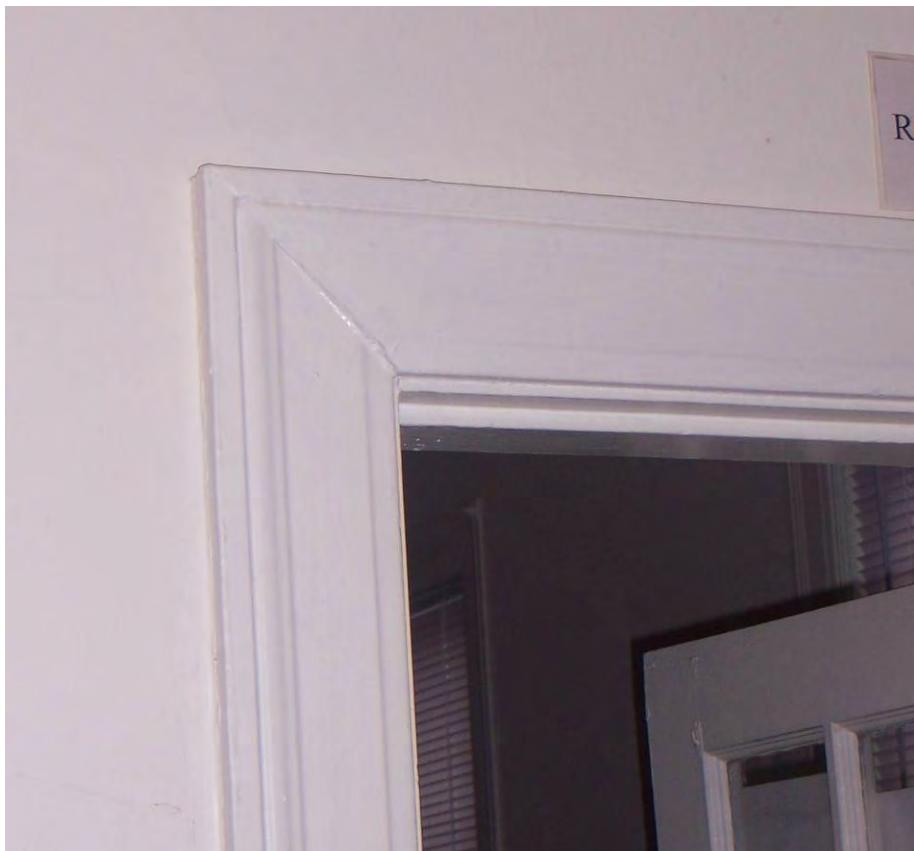
Figure 155. Millwork around door from front hallway to living room.

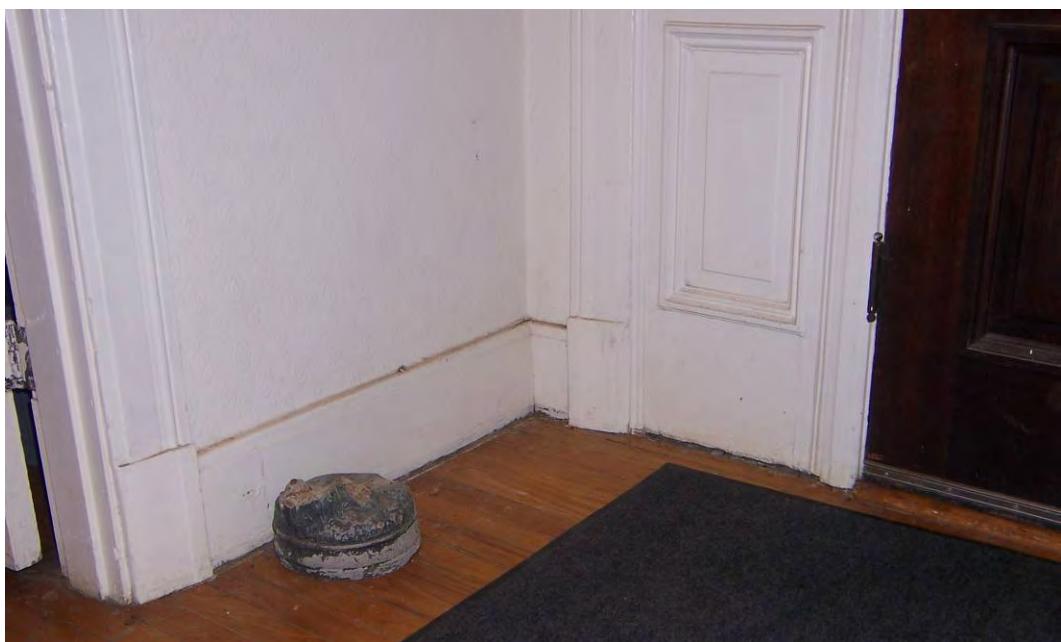
Figure 156. Millwork and floor in front hallway.

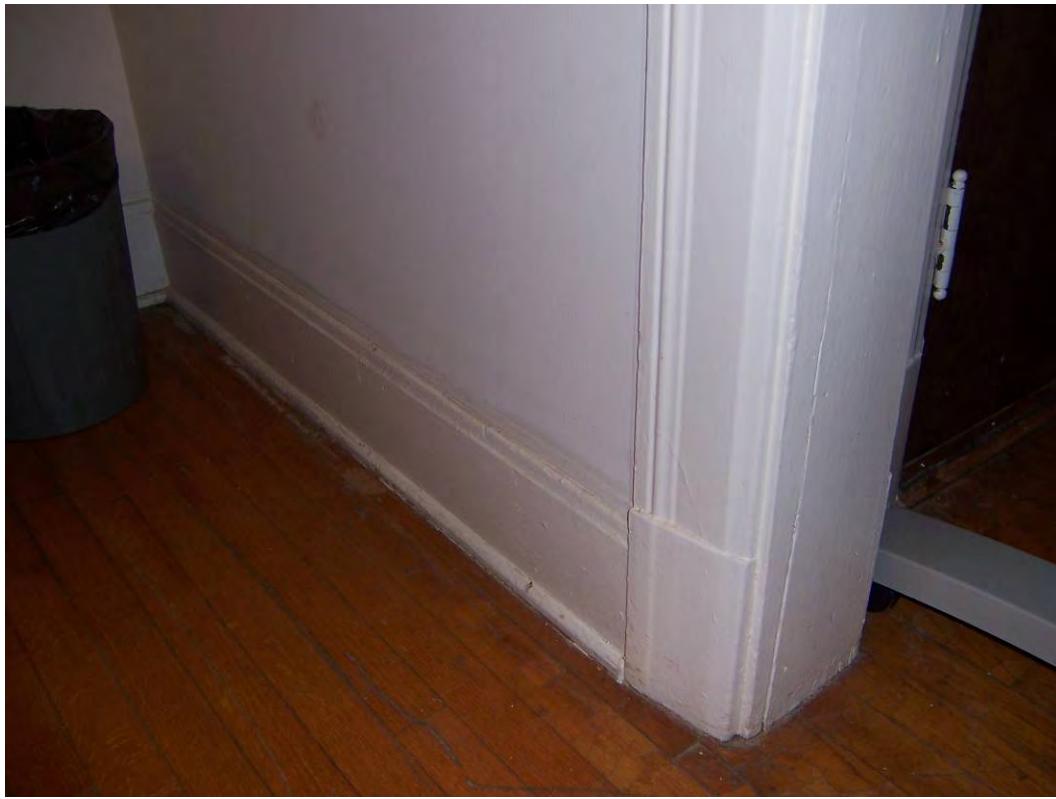
Figure 157. Millwork and floor in living room.

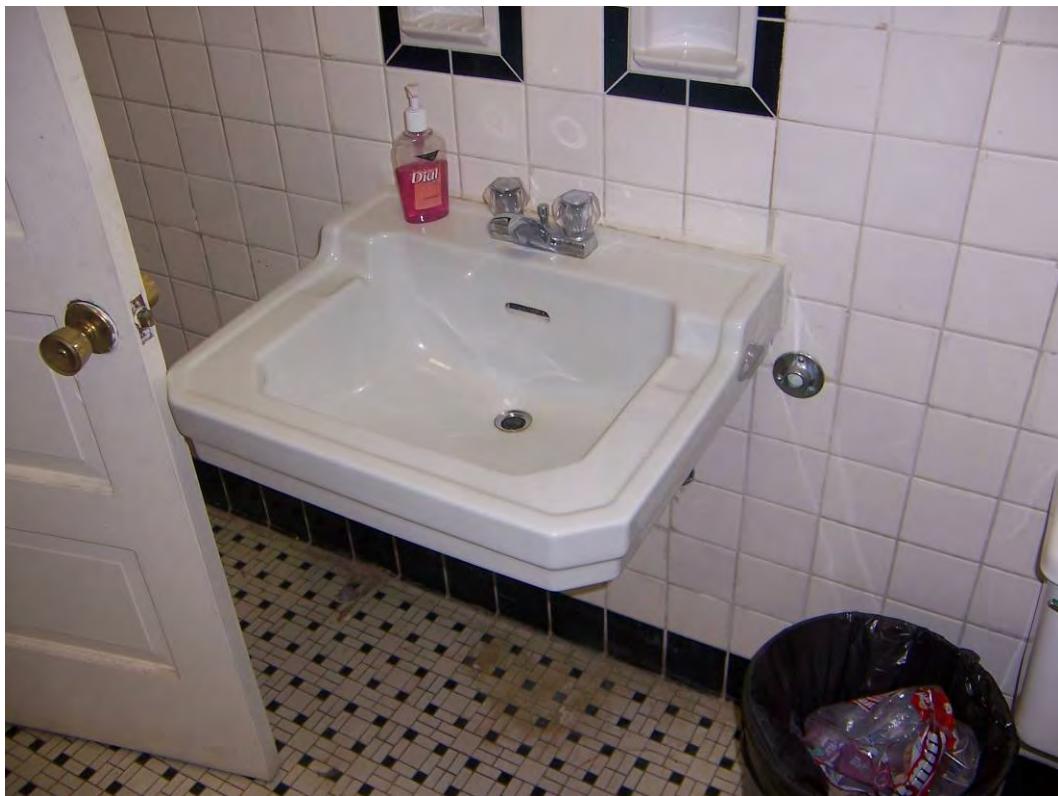
Figure 158. Original sink and tile in first floor bathroom.

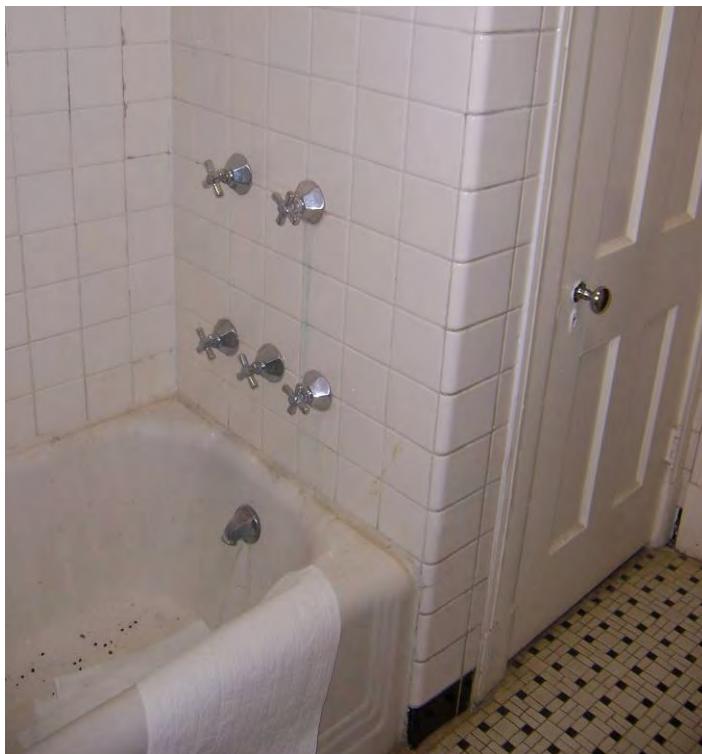
Figure 159. Original bathtub in first floor bathroom.

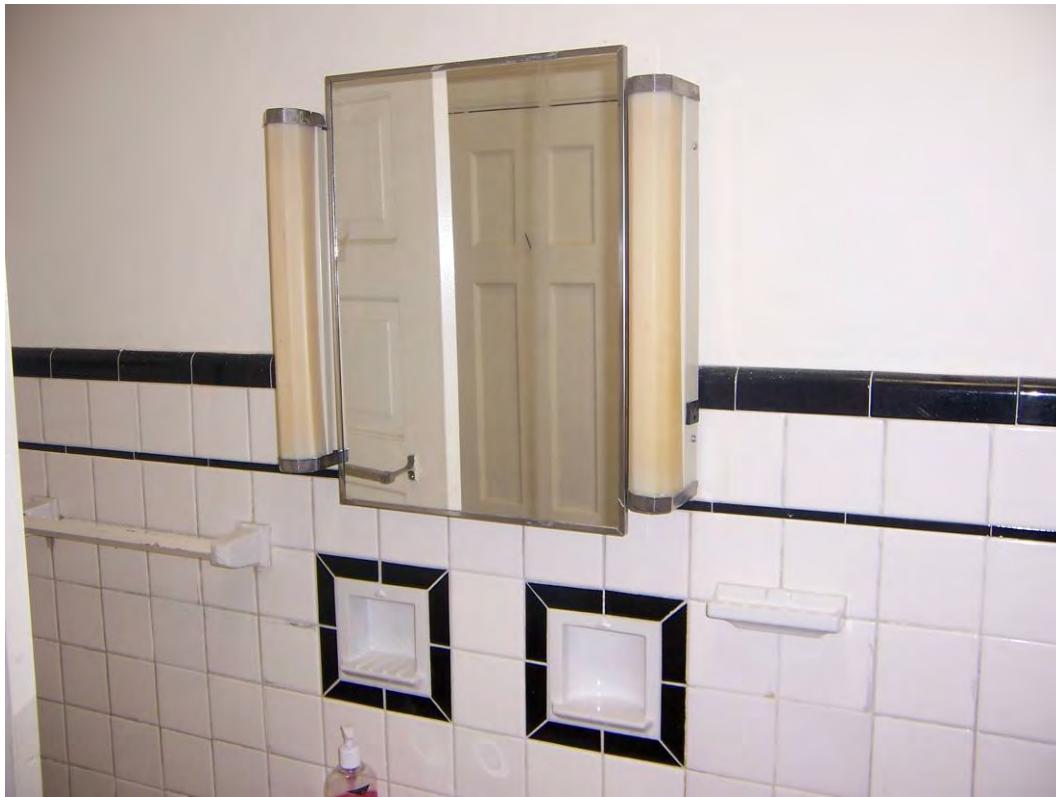
Figure 160. Original medicine chest in first floor bathroom.

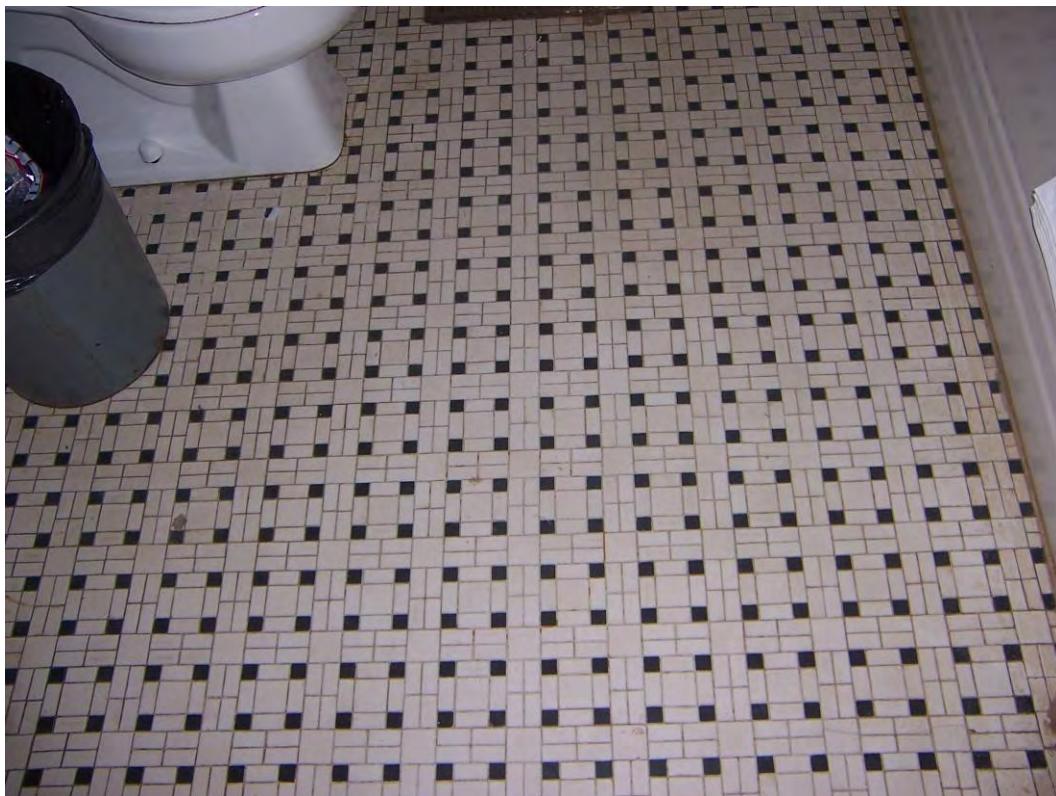
Figure 161. Original tile floor in first floor bathroom.

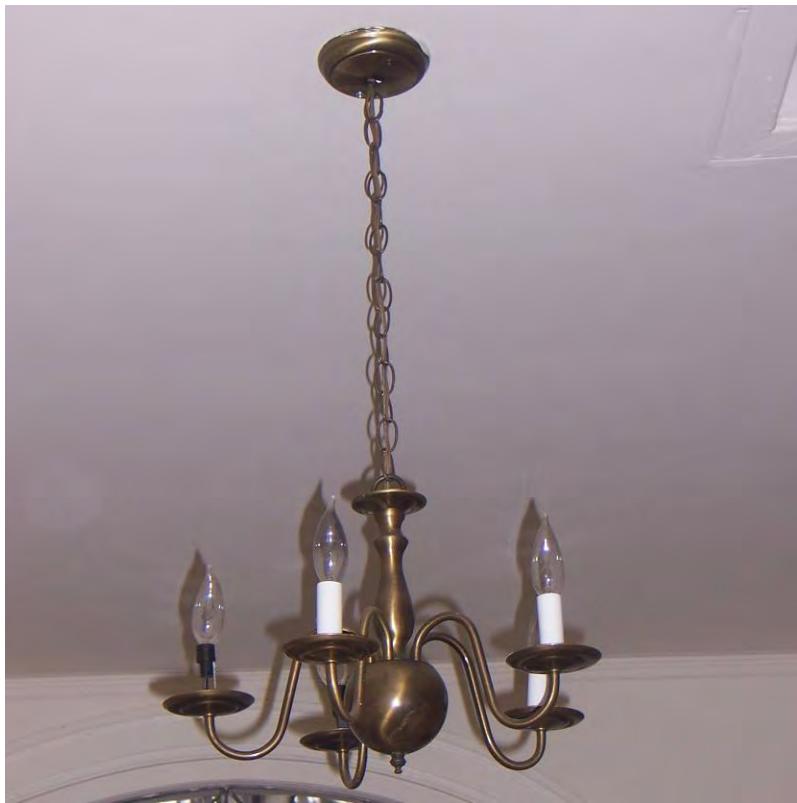
Figure 164. Replacement light fixture in entrance hallway.

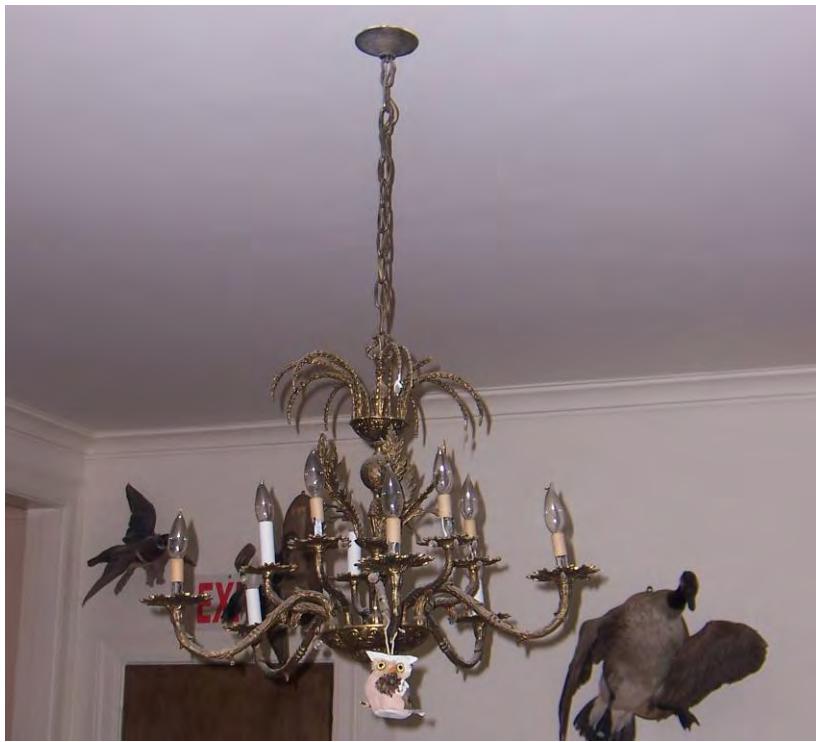
Figure 165. Original light fixture in living room.

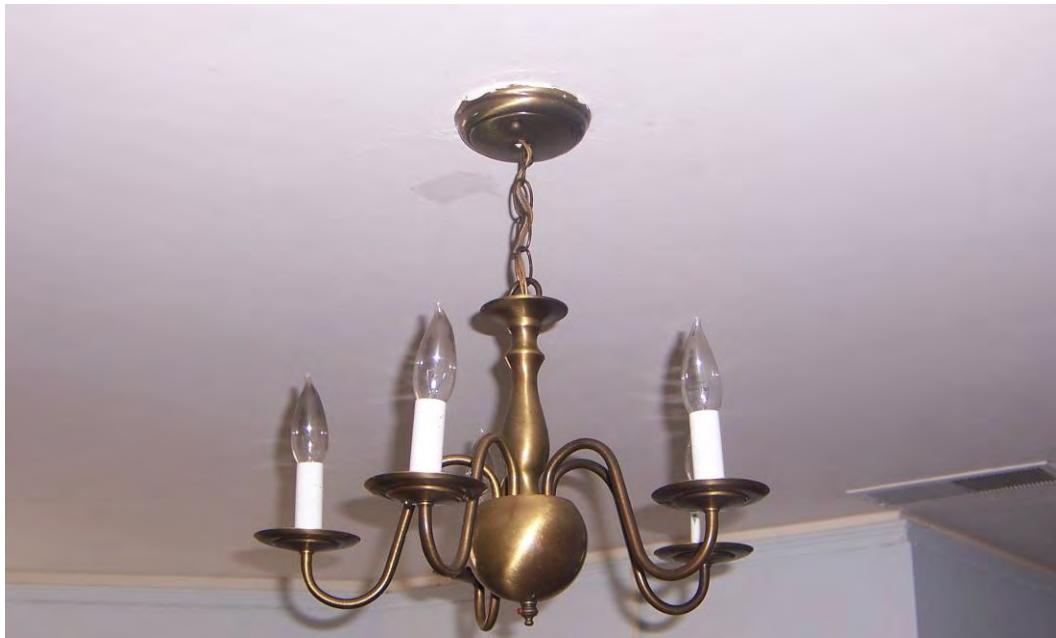
Figure 166. Replacement light fixture in upstairs hallway.

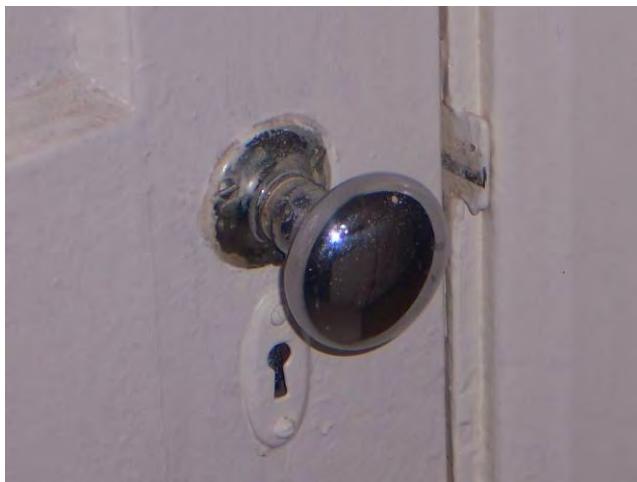
Figure 167. Original doorknob in kitchen.

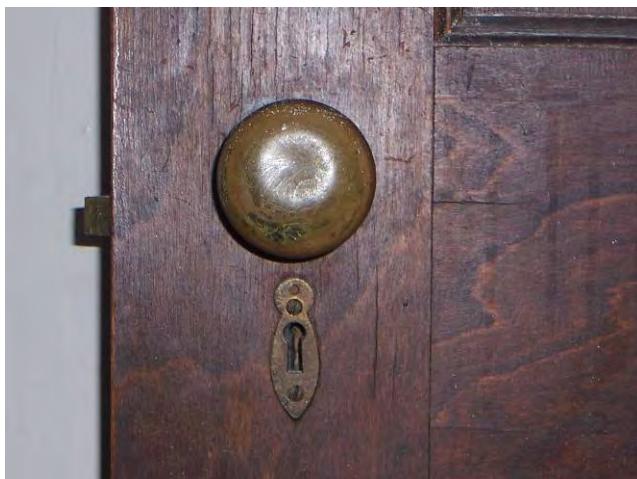
Figure 168. Original doorknob and lock in first floor bedroom.

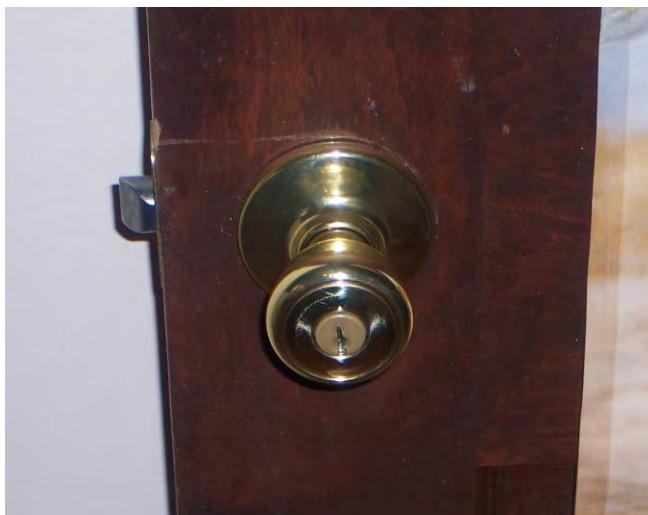
Figure 169. Replacement doorknob in first floor bedroom.

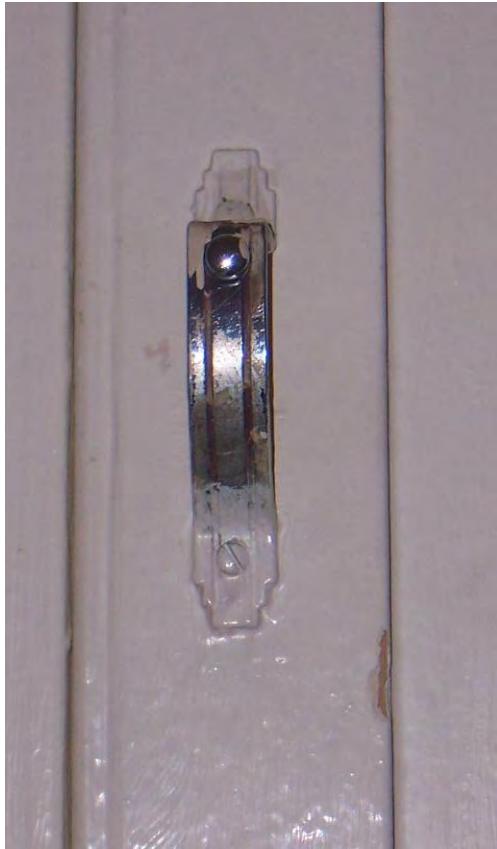
Figure 170. Original cabinet door pulls on hyphen cabinets.

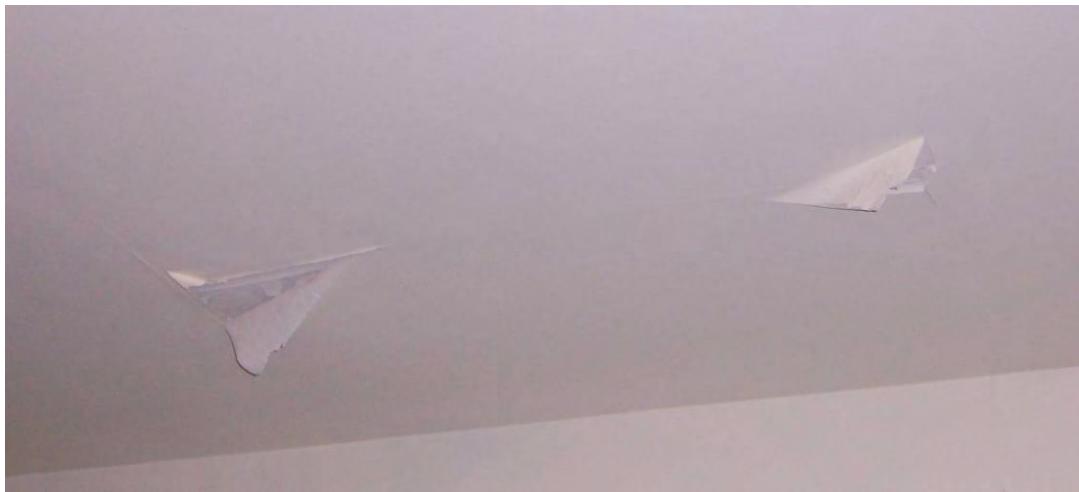
Figure 171. Plaster damage in northeast first floor bedroom.

- Plaster is cracked and/ or damaged in areas throughout house – any repair or maintenance of the plaster should be executed by a qualified professional. For more information on plaster repair and images of problem areas, please see pages 209-218.

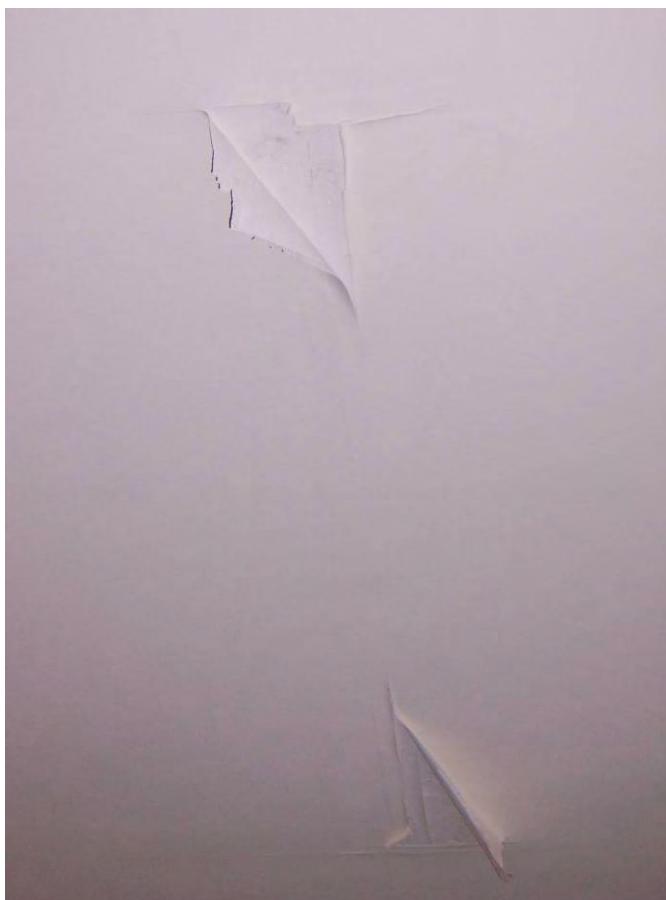
Figure 172. Plaster damage in northeast first floor bedroom.

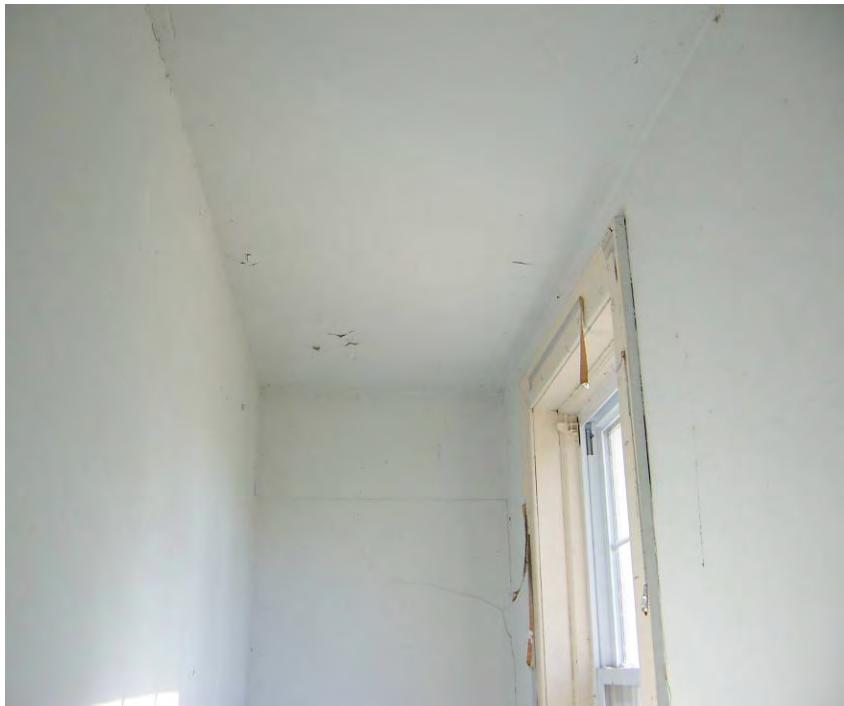
Figure 173. Plaster damage in stairwell down to garage from kitchen addition.

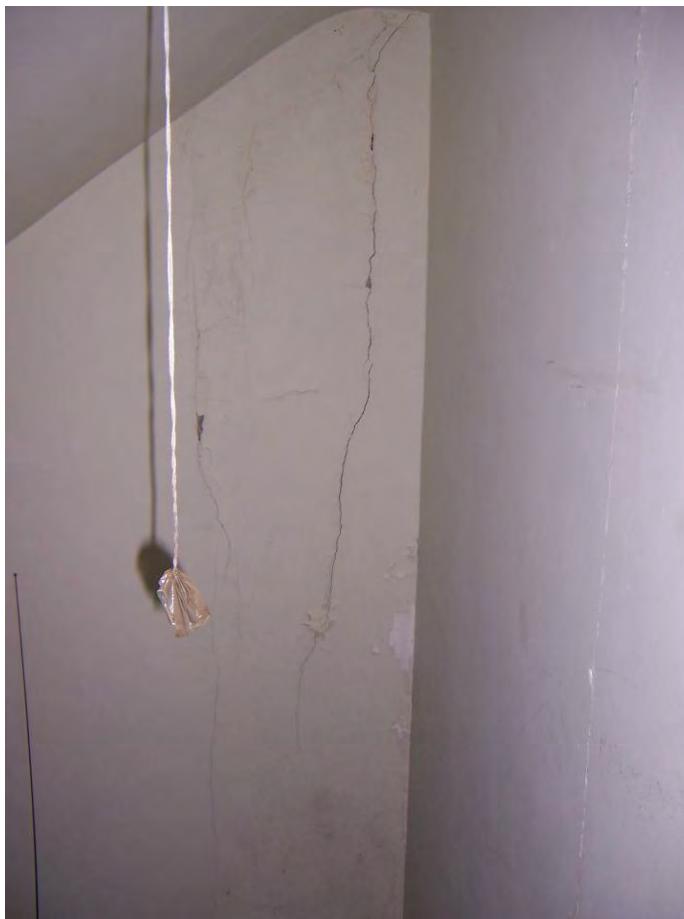
Figure 174. Cracking plaster wall in upstairs closet.
